# AN SEM ANALYSIS OF BEARING FAILURE DUE TO ELECTRICAL ARCING

W. Wiebe, D. D. Morphy

National Aeronautical Establishment

AERONAUTICAL NOTE  
NAE-AN-3  
NRC NO. 20936

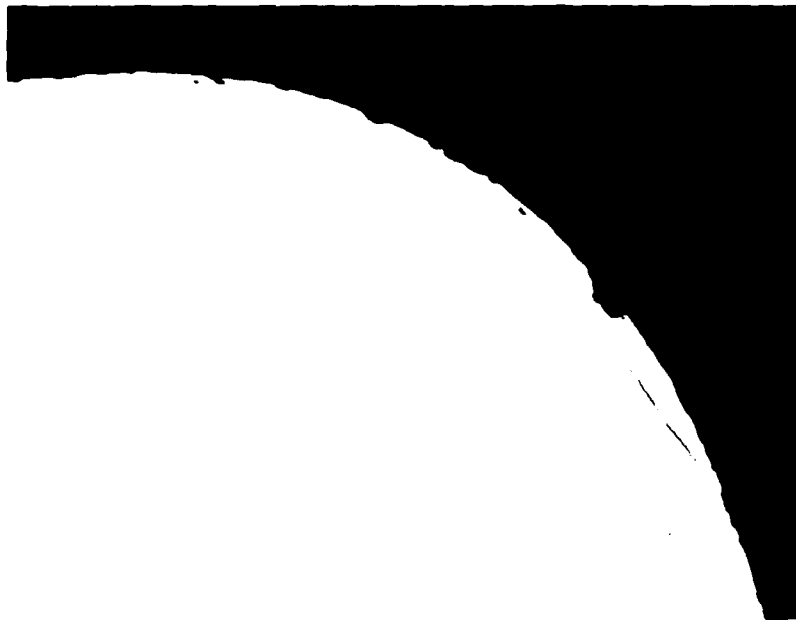
A metallographic section of a ball from bearing "B" indicated sub-surface cracking, Figure 11, resulting from abnormal localized surface stresses during rotation, due to coarse surface irregularities. Such sub-surface cracking likely corresponds to the formation of the low cycle fatigue fracture surfaces, as illustrated in Figure 8. Hardness measurements on the sectioned ball indicated values of 62Rc, which is apparently appropriate for steels used in the rolling elements in this type of bearing<sup>1</sup>.

FIG. 11: SUB-SURFACE CRACKING ON BALL FROM BEARING "B"
